Inspection Report

Minerals Regulatory Program

Mine Name: Cloudy Moon
Operator Name: Moon Mountain Stone

Permit number: S0370116
Inspection Date: April 29, 2008
Time: 9:50-10:10

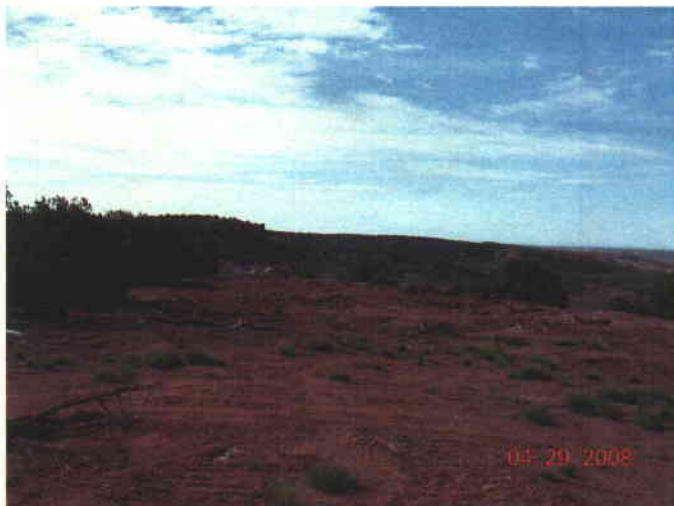
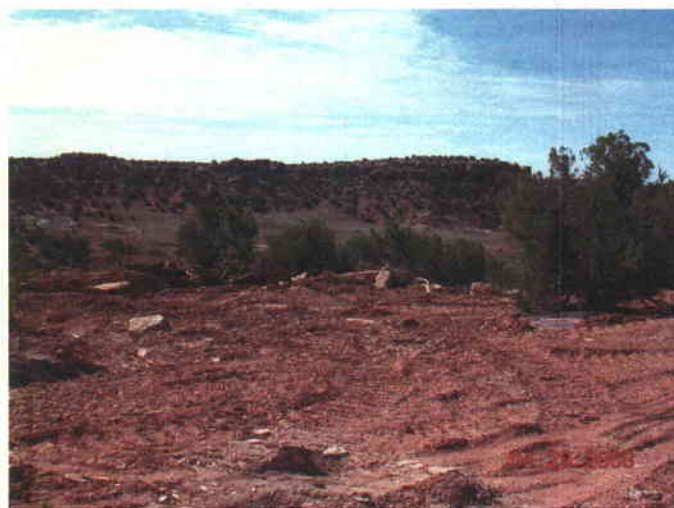
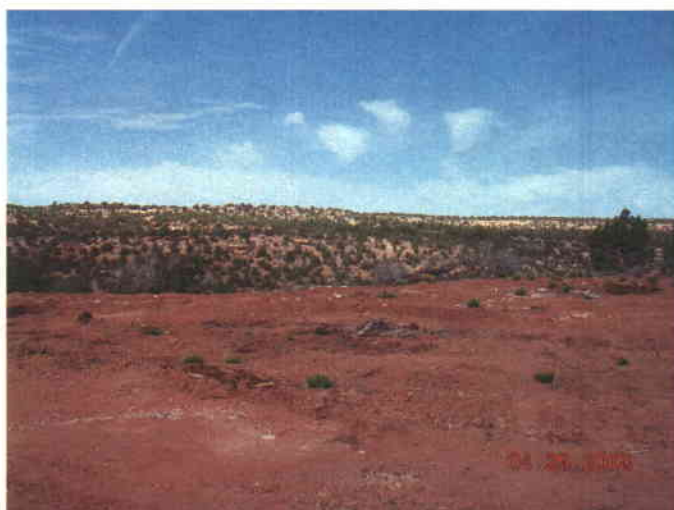
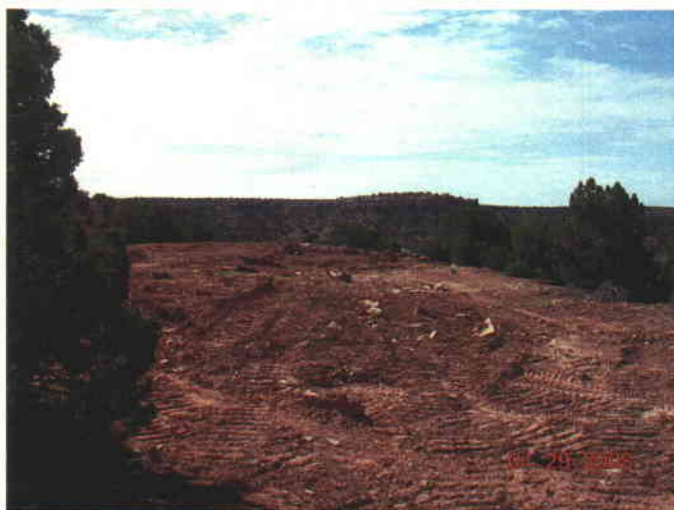
7. Backfilling/Grading (trenches, pits, roads, highwalls, shafts, drill holes)
There was not a lot of regrading to do, but the operator's contractor has completed the grading and did a good job. The site was moderately rough, and the contractor spread juniper slash around. I found seed but no seedlings.

Photo 1. These four photos show various views of the site, including both the west and east quarries.

Violation MN2007-03-09 has been abated and can be terminated. The Division and the operator will need to monitor the site for revegetation success.
